St. Mary's Church

Concrete Repair

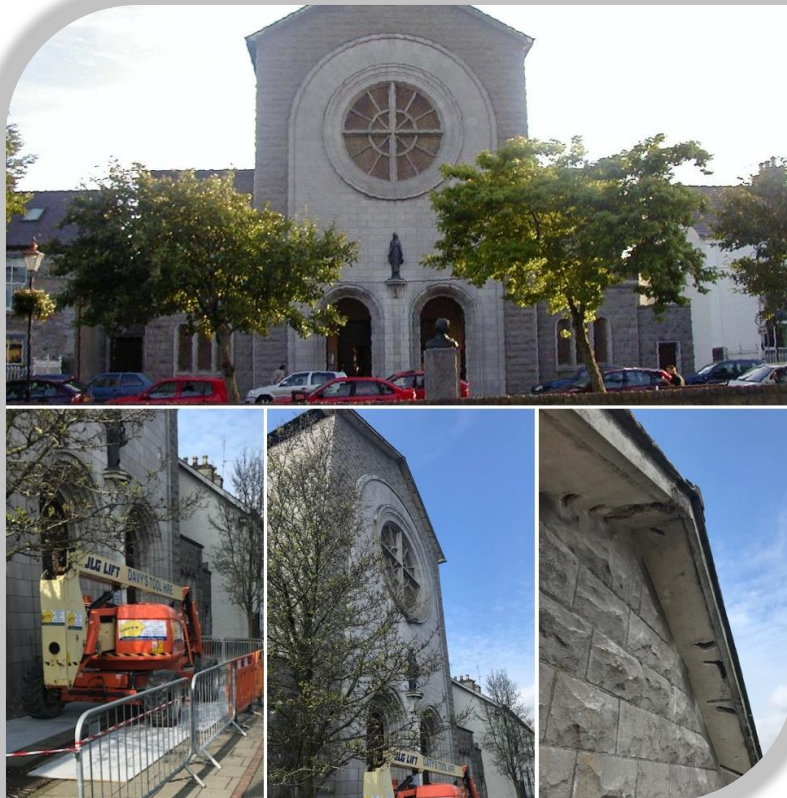
Located in the heart of Westport, the St. Marys Church that we see today was built in 1932, with its current façade being added in 1961. The old church was starting to show its age in certain locations, which required serious localized non-structural concrete repair to many of the soffits and the rooftop haunches.

As part of the major overhaul of the church, Larsen Contracts were awarded the concrete repair package; which required two forms of access, namely scaffolding access throughout the church and access via cherry picker to the front façade. All repairs were mechanically broken out to expose rebars, which were subsequently shot blasted to SA2½ using a compressed air steel-ball shot blasting unit; primed using two coats of a **Rust Inhibitor M / Betrofix R2** mixture and finally repaired using **Betrofix R3**. Repaired soffits were treated using **Impregnation Primer** followed by two coats of **Concrete Acrylic**, leaving them looking aesthetically pleasing and structurally sound.

External haunches were repaired in the same manner but were however treated using **MB2K** to leave them watertight and protected from Westport's Atlantic weather conditions.
