Concrete Repair and Protection - Fareham Shopping Centre, Hampshire

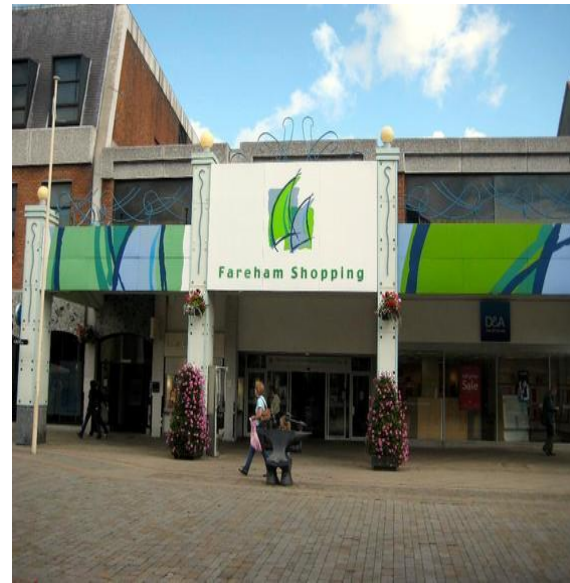
The main finding from the survey was low cover to the reinforcing steel which was resulting in the carbonation of the steel and spalling of the concrete. Larsen's solution involved high pressure water jetting to clean all concrete surfaces, followed by mechanical breakout of the damaged areas and blast cleaning of any exposed reinforcement. All of the damaged areas were then reinstated using a BASF hand placed repair mortar system. The entire surface of the concrete reinforced elements were then treated with a protective and decorative anti-carbonation coating.
