Façade Repair and Render

Eircom Athlone

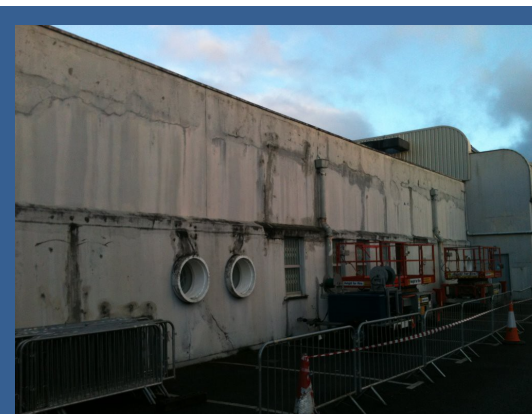
The 1970's Eircom exchange building was suffering from extensive cracking to the exterior. The Building which was of architectural interest with curves and portholes required repair and restoration

Larsen Contracts were appointed to repair the exterior facades and protect with new Render coating. We carried our repairs to the exterior using Remmers Betofix a fast cure repair mortar.

The surface coating selected was Remmers Elastoflex which would give the flexibility for anticipated movement and a high quality finish to the exterior. It is also highly resistant to water and Carbon Dioxide which can damage and accelerate weathering.
