Concrete Repair

Ballymena Showgrounds

Supply & apply Remmers FAS 100 system to repair terraced areas

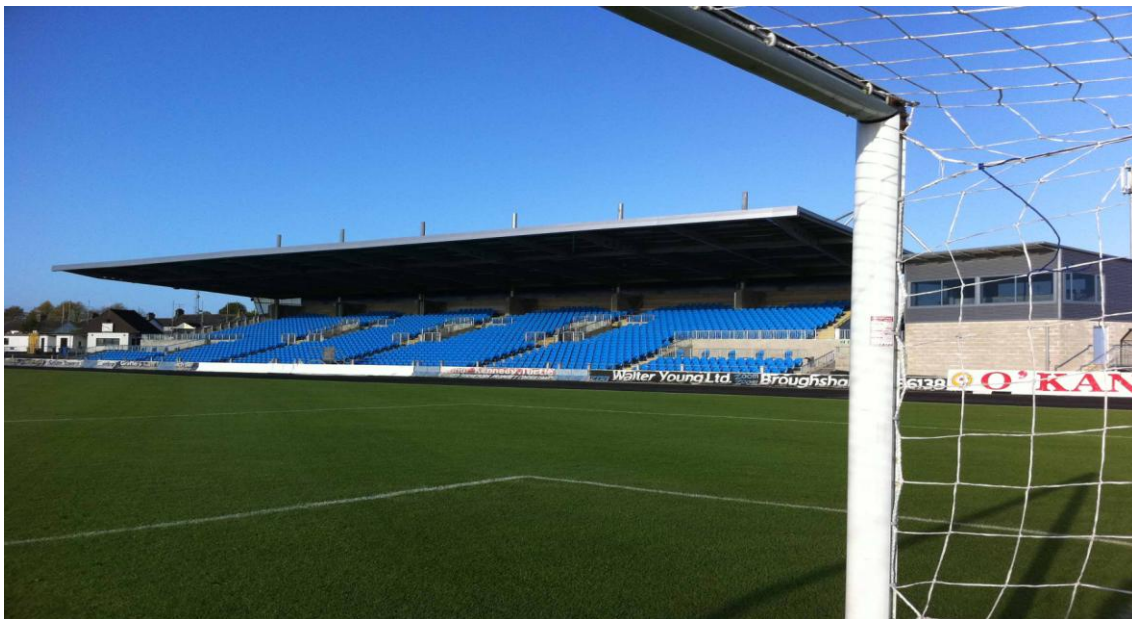
The redevelopment of Ballymena Showgrounds provided Larsen Contracts with a challenge to provide an aesthetically pleasing yet durable coating to the concrete terracing. The Warden Street stadium hosts many sporting and social events in the area. In recent years, Larsen Contracts have completed many projects for sporting facilities including resin screeding and coatings for wet rooms, toilets and corridors as well as concrete repair and protection externally.

Remmers FAS 100 system was approved by the project architect and main contractor for the repairs so that a slip resistant surface was provided. All of the existing surfaces of the treads and risers were prepared by grinding and vacuuming to remove all residual dust. This epoxy resin mortar system was supplied and applied by Larsen Contracts.
