Remedial façade repairs—

Ballymun, Dublin

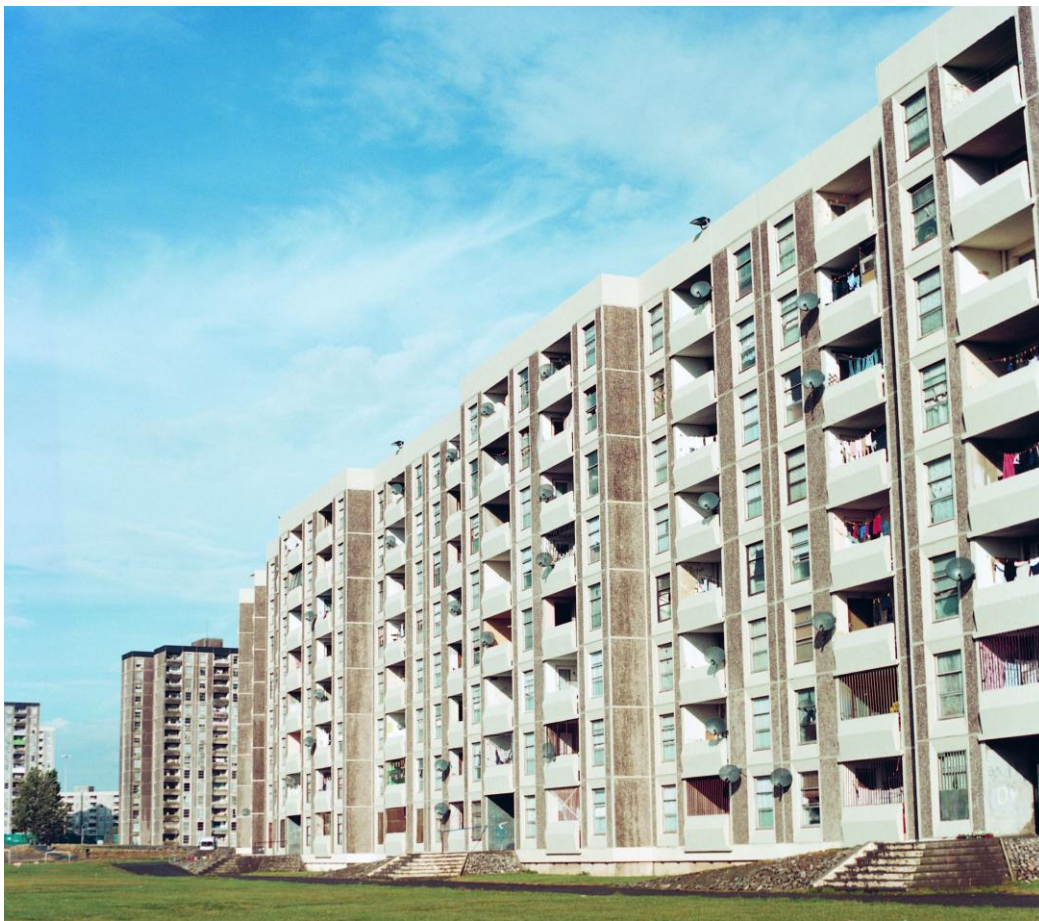
The site-fabricated, tilt up, external reinforced panel system was fixed to the RC frame with a patent steel tie inside a part insulated cavity. Over time, the waterproof jointing system would degrade and fail, allowing moisture ingress into the

cavity corroding the ties. Engineering surveys concluded that there was a high risk of tie failure which could result in the possible collapse and fall of a reinforced concrete cladding panel in a densely populated residential area.

Larsen Contracts were successful in their tender for the phase 1 & 2 works for remedial replacement of 85,000 wall ties installed on all 15, eight & four storey blocks throughout the Ballymun Complex.

The tender called for traditional access, this in itself could lead to potential Health & Safety issues as the overnight security was almost impossible to maintain. Larsen identified rope access as a much safer and suitable solution, where control of the working environment would be established and removed in a number of locations on a daily basis. The work tasks involved drilling anchor holes through the external panel and into the RC structure, installation of a high strength stainless steel wedge anchor and stainless bolts. Abseilers were able to carry all tools on their work belts and comfortably carry out the installation in a safe and efficient manner.
