Concrete Repair/Protection-

Coolkeeragh Power Station

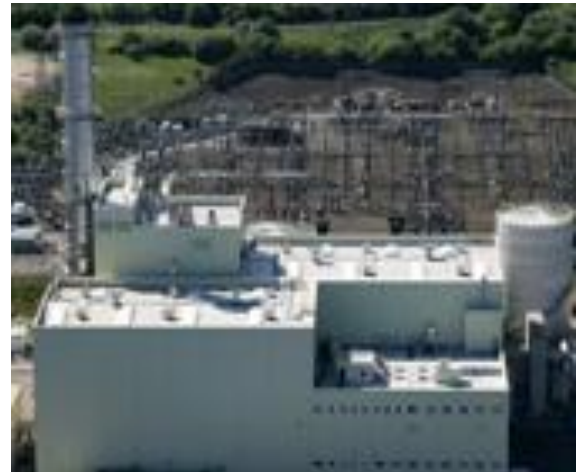
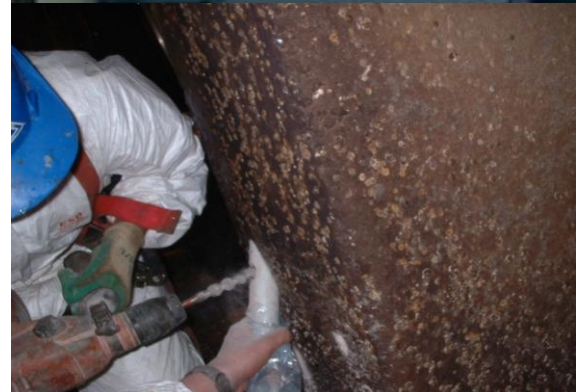
The underground cooling water cooling water culverts were constructed of reinforced concrete. The first operation was to provide a seal to the steel intake doors before draining the culverts of all water. Next, all internal joints were sealed using the Sika Combiflex jointing system. The culvert walls were all hammer tested to determine the extent of the concrete repair, defective concrete was removed and the reinforcement grit blasted and treated with an anti corrosion steel primer. All concrete surfaces were high pressure jetted to clean and remove any marine growth. Sika Ferrogard corrosion inhibitor was applied to all surfaces prior to the hand-placed and sprayed concrete repairs.

Similar repair techniques were employed in the other parts of the intake structure. The band screens and pump houses were removed of all silts and high pressured washed prior to treatment with a Sika anti-chloride protective coating system.
