Resin Flooring-Milk Processing

Project Details:

Application:
Degafloor FB , an ultra tough, slip and chemical resistant, fast-cure system.

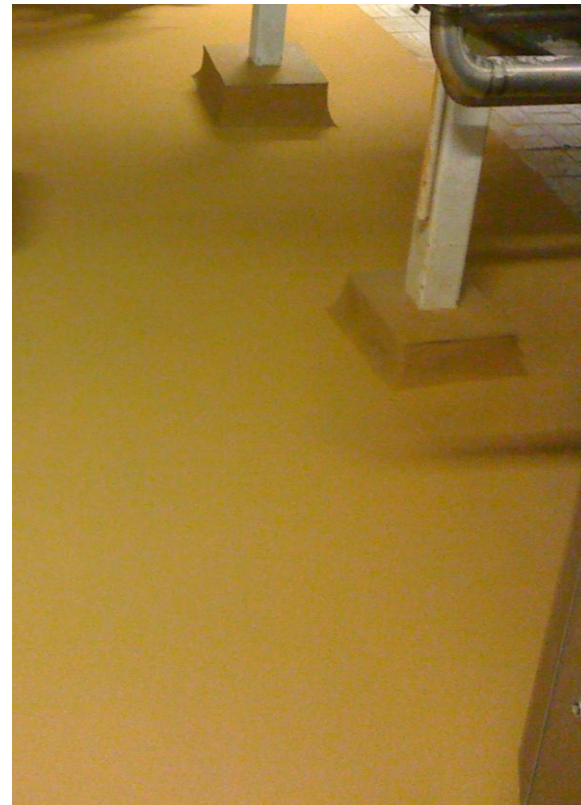
Larsen Contracts proposed the Degafloor FB system which works well in heavily trafficked areas. Defective tiles were removed and eroded concrete repaired as part of the surface preparation works. The repaired area was then screeded with a 4mm Degafloor system in saffron yellow to cleverly mask any discolouration that may occur unplanned due to lengthy exposure to nitric acid.
